Environmental Stewardship Initiatives for  
VF300 Fence Construction along the Southwest Border  
U.S. Border Patrol Tucson Sector  
August 2010

U.S. Customs and  
Border Protection

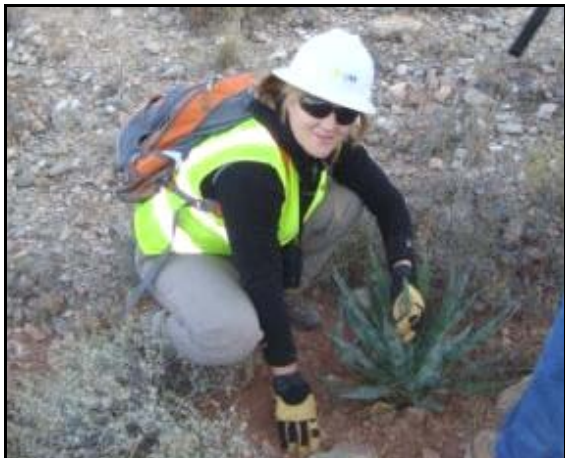
**Section FV-1B**

**An Environmental Monitor Relocates an Agave during the Early Stages of Construction**

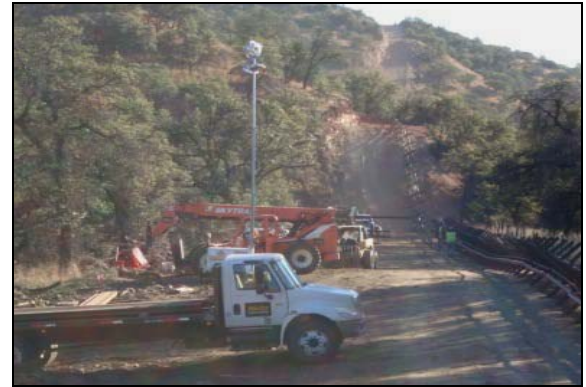
**Fence Construction at Section EV-1B**

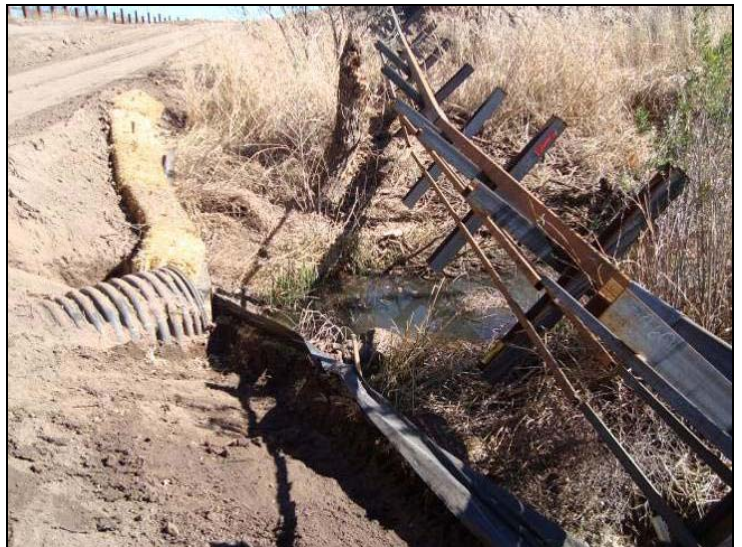
**Normandy-Style Vehicle Fence and Current Water Handling Infrastructure at the Black Draw Stream Channel Section FV-1B**

CBP's post-construction surveys identified one continuing issue that is in the process of being addressed. A bridge over the Black Draw stream channel at Section FV-1B is required to enlarge the stream channel, improve the flow of water, and reduce the potential for future issues with soil erosion. Construction of the bridge was completed in August 2010.
